Mesa Verde National Park, located in southwestern Colorado, is the site of Spruce Tree House, which is the third largest and best-preserved cliff dwelling in the Park. The nose of the alcove contains a thin arch delineated by a persistent curved crack, which extends about 270 ft north from above the south end of the alcove. Recently, rockfalls from the arch and adjacent rock surfaces demonstrated the need for a new assessment of arch stability and stabilization. Itasca was retained by the National Park Service (NPS) to investigate the arch, conduct a stability assessment, conduct 3D modeling, identify remediation options, recommend the preferred option, and estimate construction costs.

Project Background

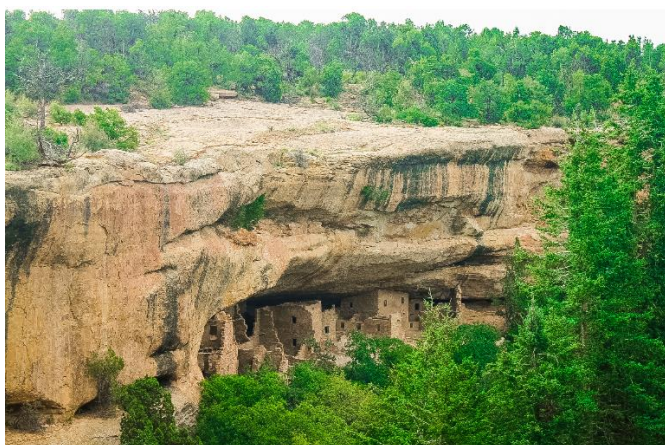
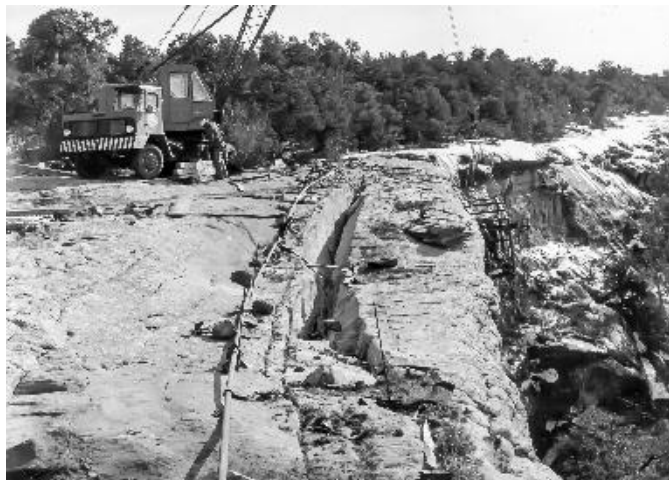
north from above the south end of the alcove. The crack is up to several feet wide, and the arch cross section is roughly 10 ft thick by 20 ft high. A 1960s investigation led to a stabilization program that included rockbolts and a thorough cleaning and grouting of the crack. Recently, rockfalls from the arch and adjacent rock surfaces demonstrated the need for a new assessment of arch stability and stabilization.

Figure 1 Current appearance of Spruce Tree House Alcove (left) and 1960s Cleaning of the Richardson Crack (right)

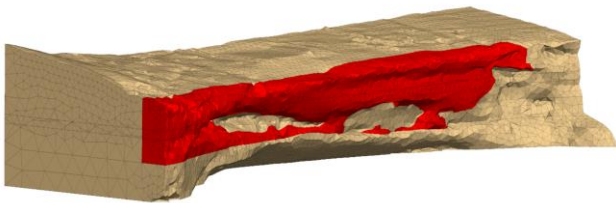
Figure 2 Full 3DEC Model with the arch in red.

portion of the Richardson crack that was remediated in the 1960s is believed to have frictional properties but no cohesion. The Richardson crack was extrapolated north and south of the remediated segment. The extrapolated segment is believed to have both cohesion and friction. The model was calibrated, meaning sandstone strength properties were adjusted, so that the arch was just stable with the existing 1960s rockbolts discounted.

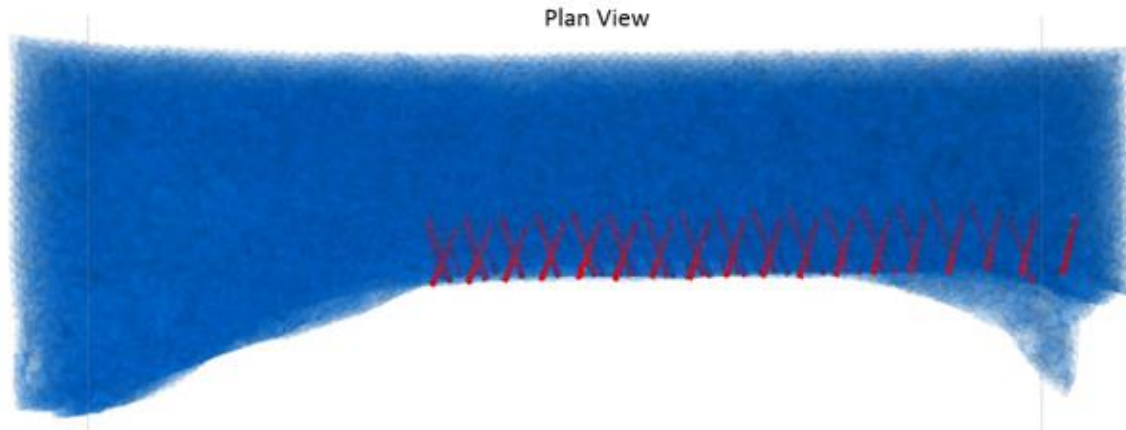
Figure 3 Plan view of reticulated bolt pattern for the 58-bolt option.

Three rockbolt configurations were modeled, reticulated and unreticulated patterns with 79 25-ft long rockbolts installed in three rows, and a reticulated pattern with 58 18-ft long rockbolts in three rows. The recommended rockbolt type is a Williams R1H high grade, hollow-core, pretensioned rockbolt with a yield load of 100,000 lbs, tensioned to 38,000 lbs.

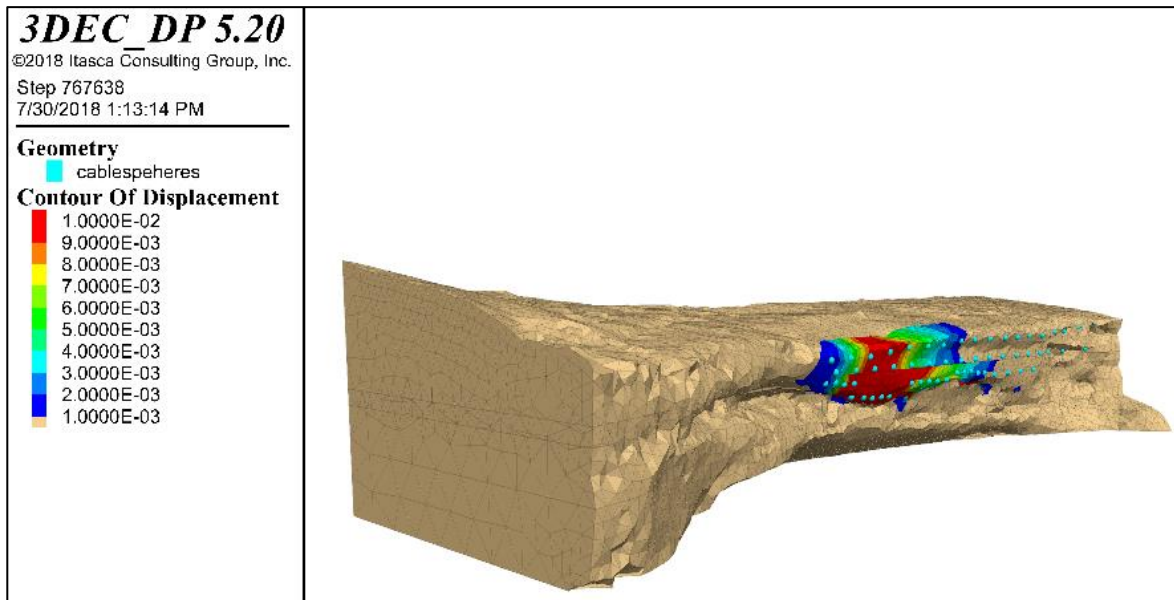
The entire model appears to be stable up to a factor of safety of 2.0. The velocities at the six recorded locations all converge to near-zero, with the rock below the shale layers exhibiting the most movement and the zones exhibiting failure is limited. Once the SRF is increased to 3.0, the rock below the shale seams does not appear to converge, but the section of the arch above the shale seams converges. Observing the failure state of the zones in the model, the failure is much more extensive at an SRF of 3.0 than at 2.0, including an increase in shearing in the southern pillar and tension in the northern pillar.

Figure 4 Model displacements for a factor of safety of 2.0 for the 58-bolt reticulated pattern.

- The entire model appears to be stable up to a factor of safety of 2.0.
- The reticulated pattern more effectively stabilizes the arch by stitching the rock together.
- The analysis also showed, based on predicted rock bolt axial forces from the 25-ft long option, that shorter rock bolts would be adequate.
- The 3DEC model also predicted that the recommended remediation would not stabilize blocks on the underside of the arch.
